NUMBER
PI2002Y/Z

DATE
April 2021

PRODUCT IMPROVEMENT CAMPAIGN

**SUBJECT: ENGINE REPLACEMENT INSTRUCTIONS
FOR DTC P1326 (PI2002Y/Z)**

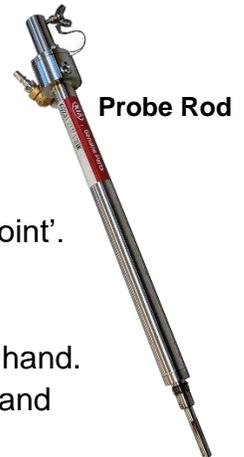
This outline provides information regarding the application of Loctite® Threadlocker Blue 242 to the dial gauge 'measuring point' end included in the Engine Bearing Clearance Tester (BCT) kit SST KQ231 2T110QQK. This extra step helps reduce the possibility of the measuring point tip loosening on the dial gauge due to repeated use. If measuring tip comes loose, inaccurate BCT measuring readings will result.

1. Unscrew the 'measuring point' end (A) from the base of the dial gauge.
2. Apply one drop of blue Loctite® to the threaded end of the 'measuring point'.
3. Reinstall the 'measuring point' end back onto the dial gauge finger tight.
4. Fully insert the dial gauge into the probe rod.
5. Secure the gauge to the probe rod by tightening the locking wing nut by hand.
6. Test gauge operation by pressing the lower bar of the probe rod inward and verify the gauge readings correspond with the movement of the lower bar.

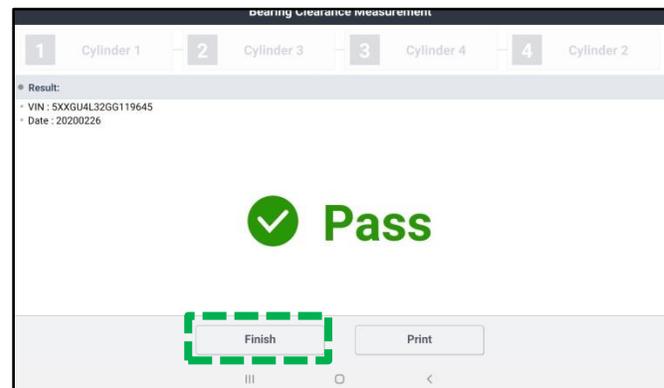
If the test result displays **"NO PASS"**, capture the screen image/screenshot for record keeping. Then proceed to replace the engine assembly per the instructions.

- Proceed to **page 14** to replace the engine assembly as outlined in this bulletin
